**Lincoln Hancock Restoration
Emergency Response Agreement – Inspection Report**

Name of Community: **Ocean Cove Villas**

Address: 25 Mooring Bay Hilton Head, SC 29928

Date: July 11, 2013

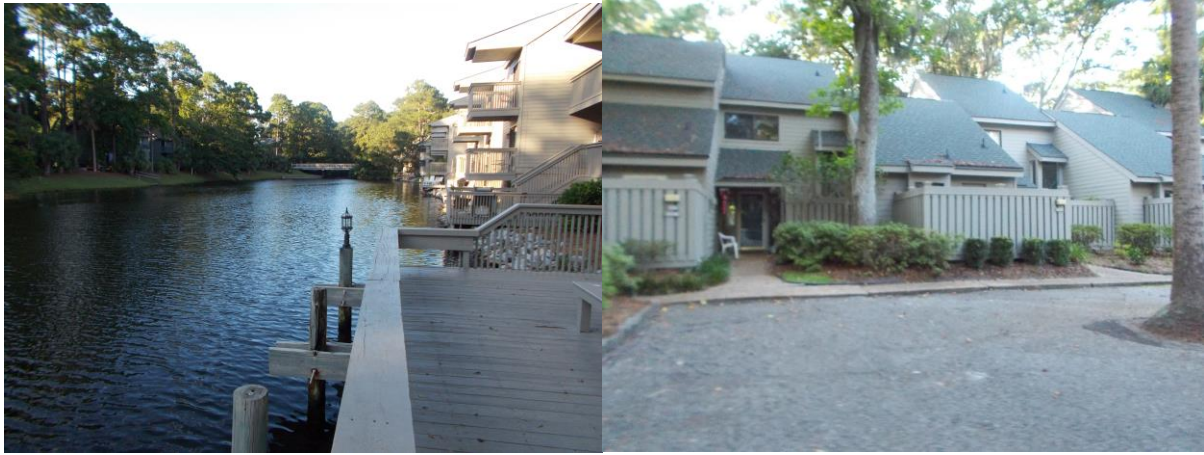
21. What type of roof system(s):

Asphalt sloped

22. Condition and age of roof:

10-
