**Lincoln Hancock Restoration
Emergency Response Agreement – Inspection Report**

Name of Community: **The Greens**

Address: 113 Shipyard Drive Hilton Head, SC 29928

Date: July 11, 2013

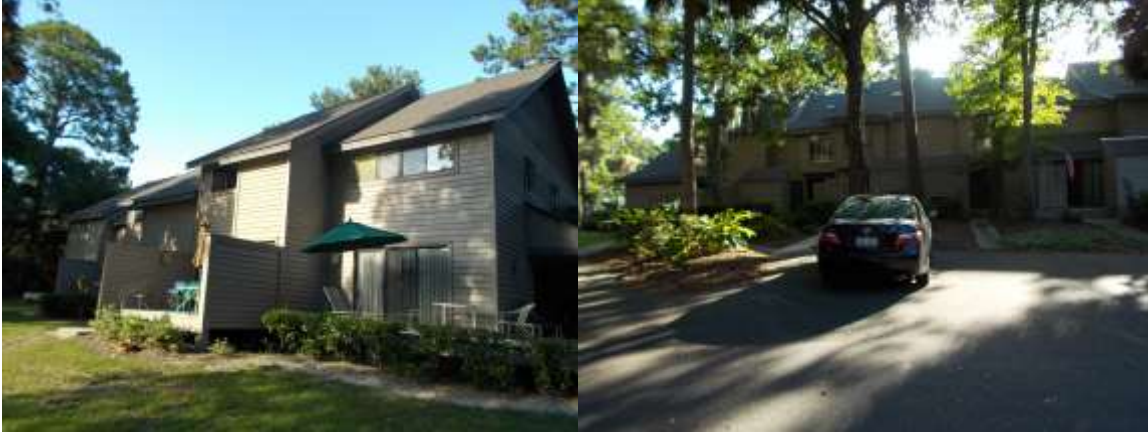
- 22. Condition and age of roof: 10- 15 Years
- 23. Do storm shutters exist on all windows/doors: No
- 24. What type of exterior covering siding is on buildings: Wood Clad
- 25. Will tree fall be a likely issue that blocks access to the property or damages buildings:
Yes, heavy
- 26. Is there a marina: No
- 27. General notes and concerns: None
